INDOOR AIR QUALITY ASSESSMENT

**Lillie B. Merrill Elementary School
687 Pleasant Street
Raynham, MA**

Prepared by:
Massachusetts Department of Public Health
Bureau of Environmental Health
Indoor Air Quality Program
November 2017

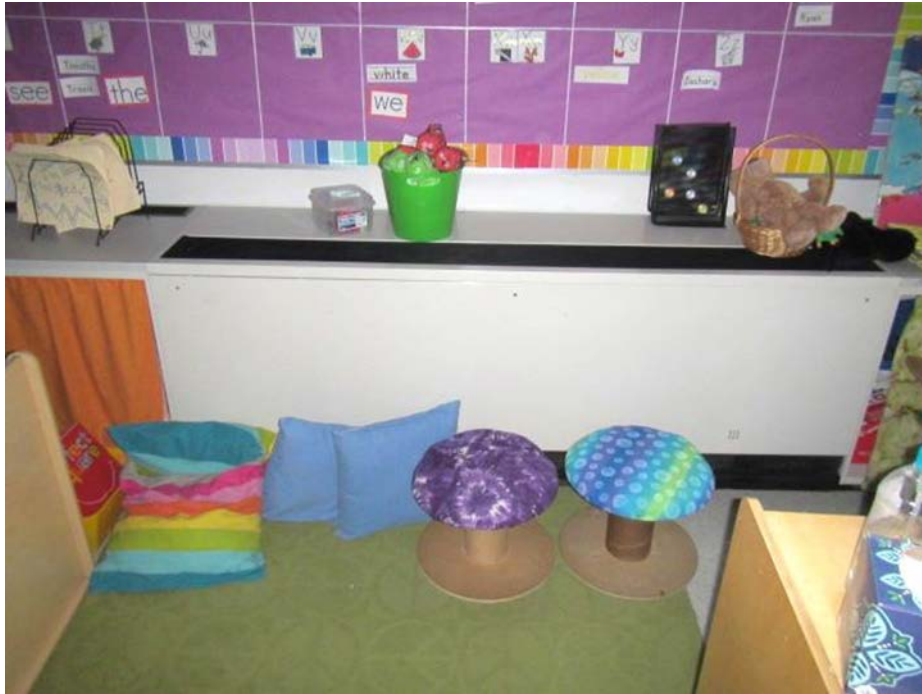
Picture 1

Fresh air is provided by a combination of unit ventilators (univents) located in individual classrooms (Picture 1) and air handling units (AHUs; Picture 2), which serve a few classrooms, the gym and office/common areas. The unit ventilators draw fresh air through a vent on the exterior wall (Picture 3). Fresh air is mixed with return air from the room, filtered, heated or cooled as needed (Figure 1) and delivered to rooms via ducted supply vents (Picture 4).

To maximize air exchange, the MDPH recommends that both supply and exhaust ventilation operate *continuously* during periods of occupancy. In addition, many univents were obstructed by items placed on top or in front (Pictures 1 and 5). Both the top and the vent at the bottom need to be kept clear of obstructions for the units to operate as designed.

Classroom uninvent, note items obstructing vent along bottom front

3. Remove items and furniture blocking univents both on top and along the front.
4. Check exhaust vents (in classrooms and restrooms) for draw periodically and repair any non-operating motors/vents.

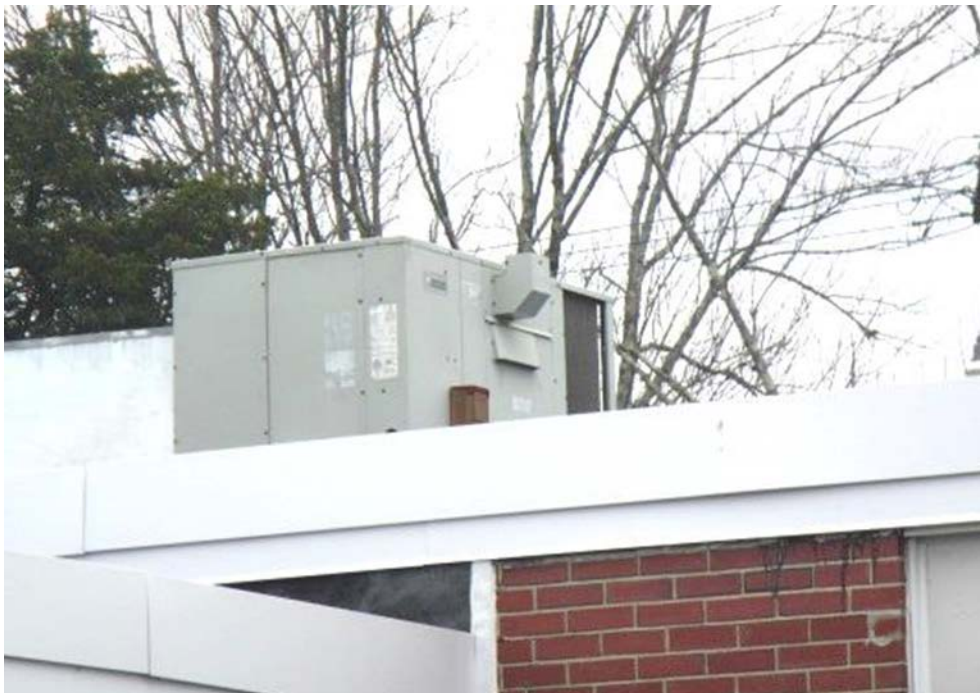
Picture 2

Rooftop air handling unit

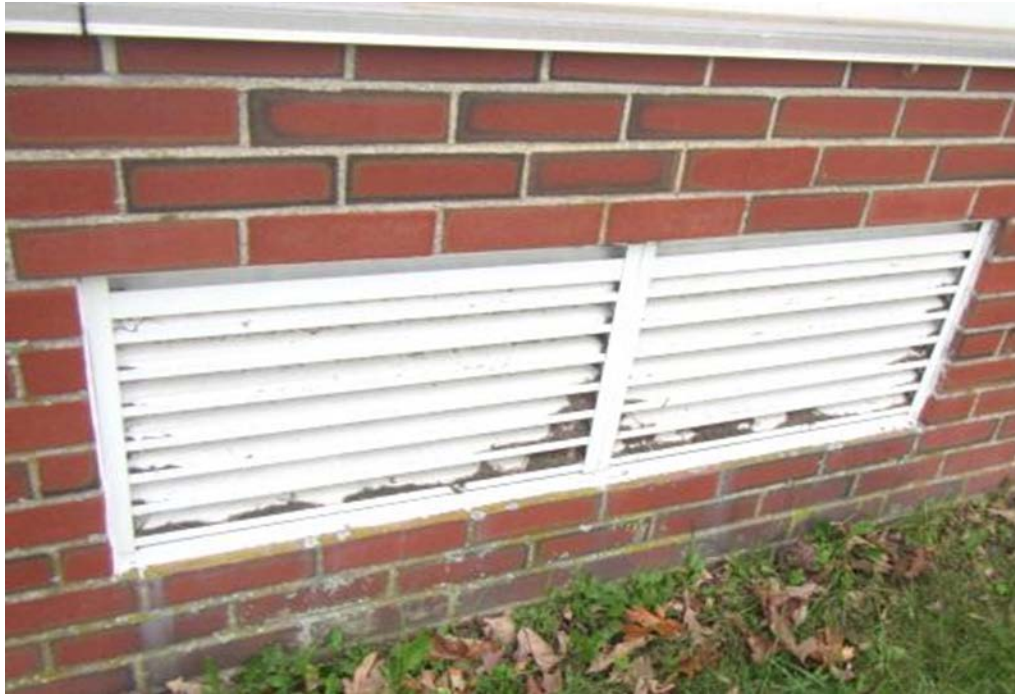
Picture 3

The univent fresh air intakes in this building have a design which makes them prone to collect debris (Picture 3). These intakes should be monitored for debris and cleaned periodically. Additionally, maintenance staff should take care when mowing, to direct clippings *away* from units.

Univent fresh air intake, note debris in louvers

18. Consider reducing the amount of items stored in classrooms to make cleaning easier. Periodically move items to clean flat surfaces.
19. Univent fresh air intakes should be monitored for debris and cleaned periodically. Ensure to direct clippings *away* from units when mowing.

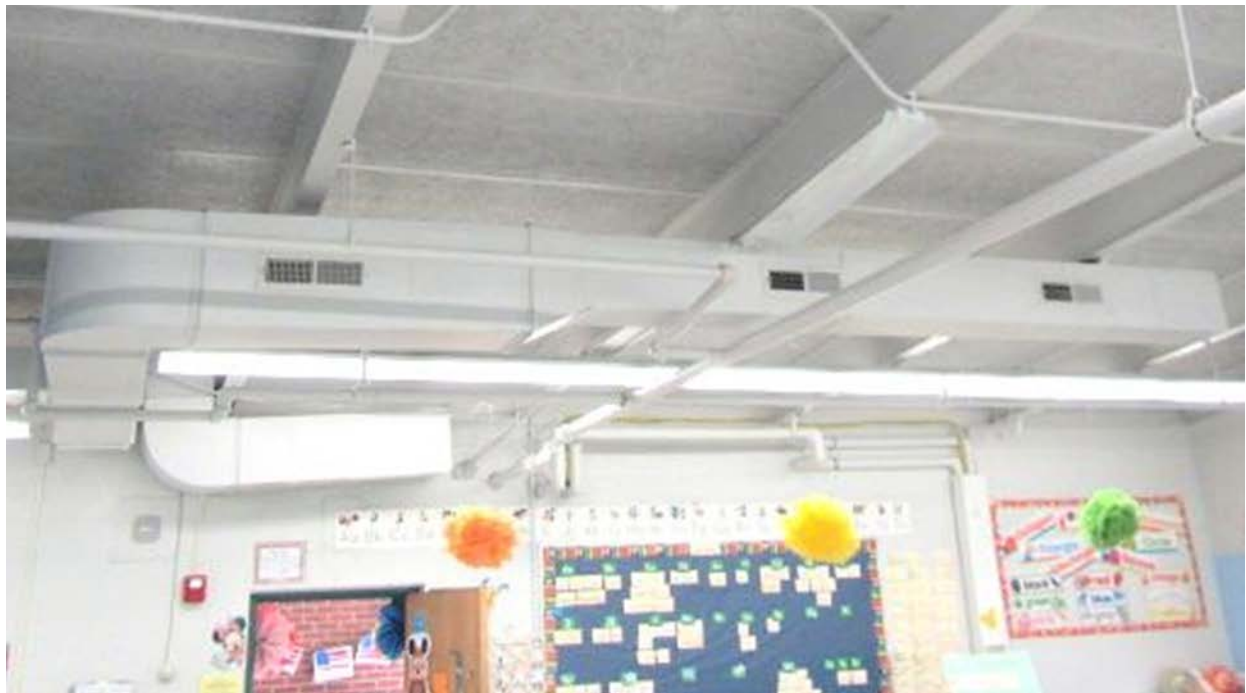
Picture 4

Ducted vents in classroom

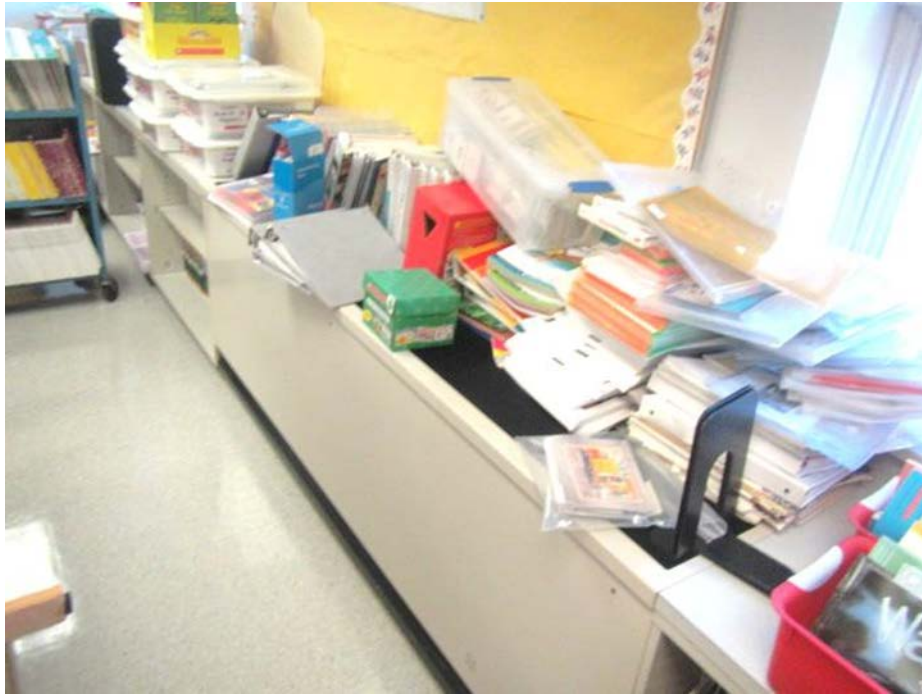
Picture 5

In many areas, items, including books, papers, toys and decorative items were observed on floors, windowsills, tabletops, counters, bookcases, and desks (Picture 5). These items can make it difficult for custodial staff to clean.

Items on classroom univent obstructing airflow

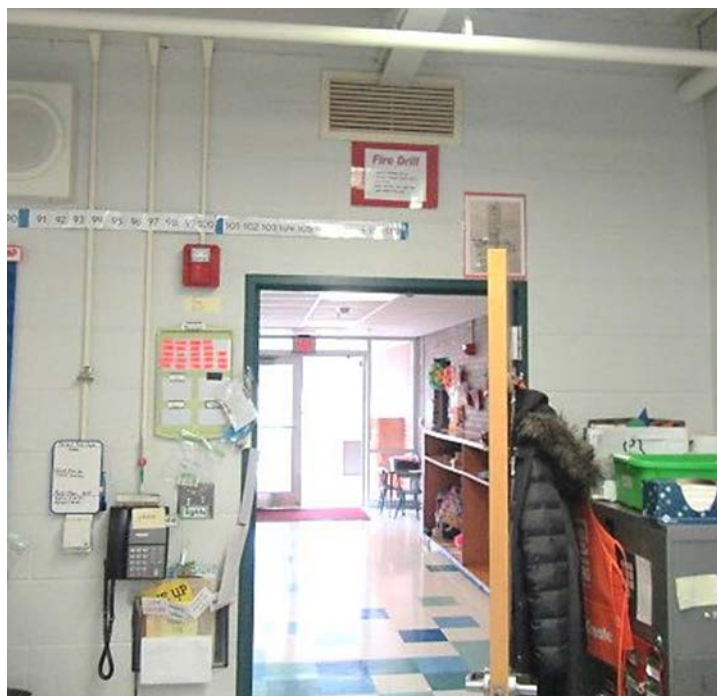
Picture 6

Air is exhausted from ceiling-mounted exhaust vents on the opposite side of the room, in some cases near classroom doors (Picture 6). Note that when classroom doors are open, exhaust vents will tend to pull hallway air *into* the classroom instead of removing stale air/pollutants *from* the room and out the building.

Classroom exhaust vent over open hallway door

5. Close classroom doors to facilitate exhaust function.
6. Consider contacting an HVAC engineer to evaluate Title 1/Pupil Support Suite to improve air circulation, some methods may include; under cutting doors or installing passive vents on doors.

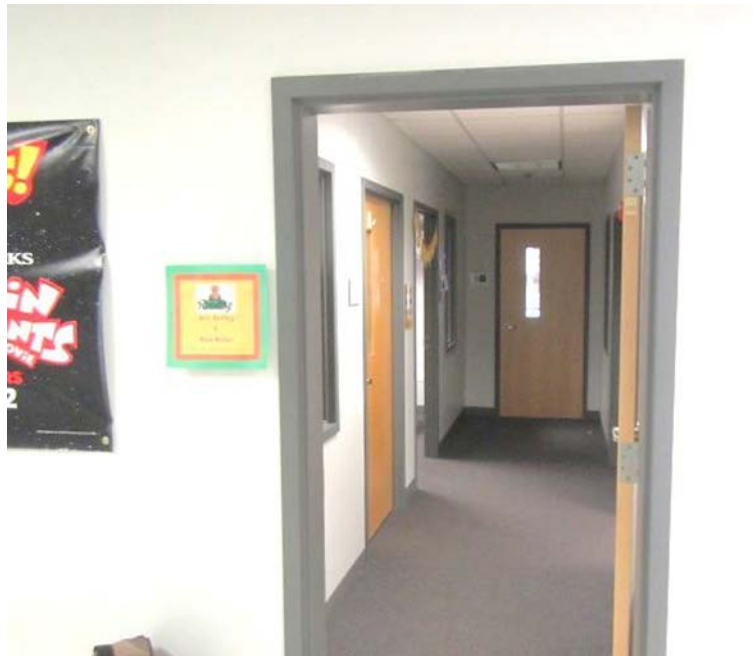
Picture 7

The Title 1/Pupil Support suite appears to be a former classroom converted into several small rooms (Picture 7). This design has impeded proper airflow in that the one supply unit is located in a room at the end of the suite (Picture 8), whereas the other rooms have no supply but are equipped with exhaust vents (Picture 9). With the doors shut to all the rooms, little airflow is exchanged.

Title 1/Pupil Support suite, note room (with closed) door at end contains the fresh air supply

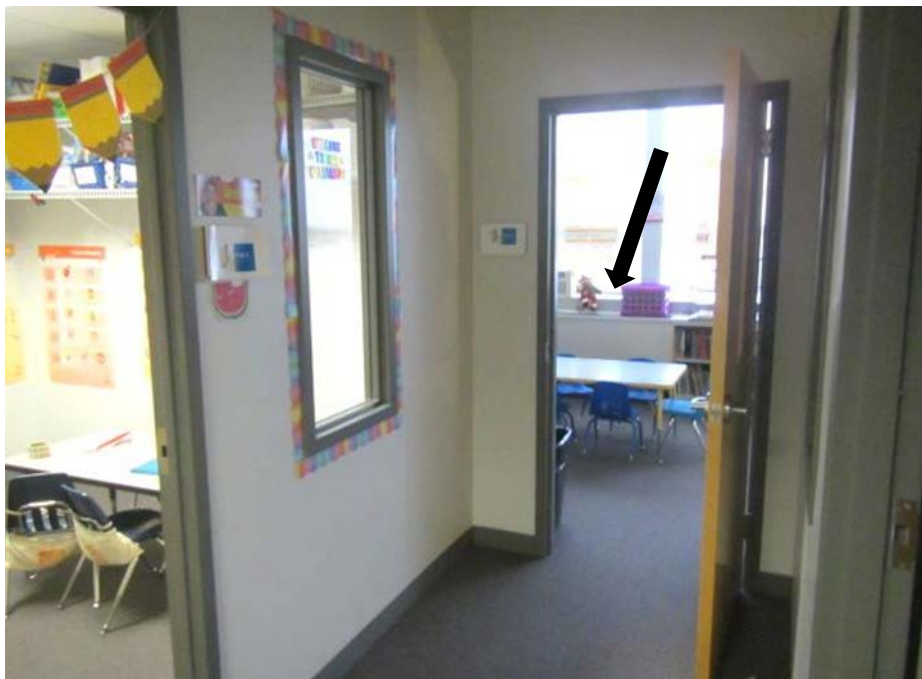
Picture 8

Title 1/Pupil Support suite, note room door at end contains the fresh air supply (arrow)

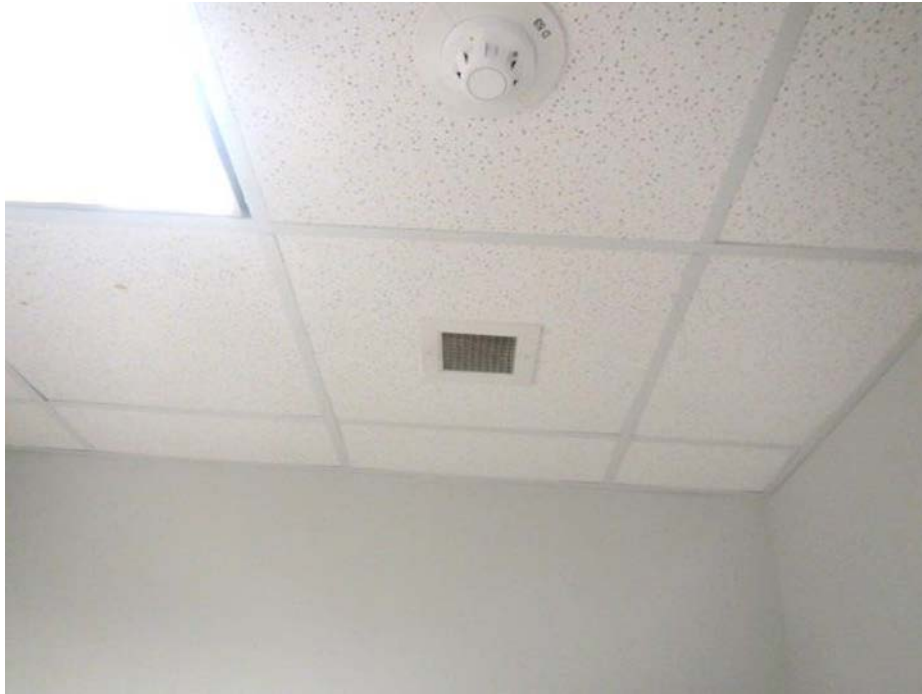
Picture 9

Ceiling-mounted exhaust vent in Title 1/Pupil Support suite

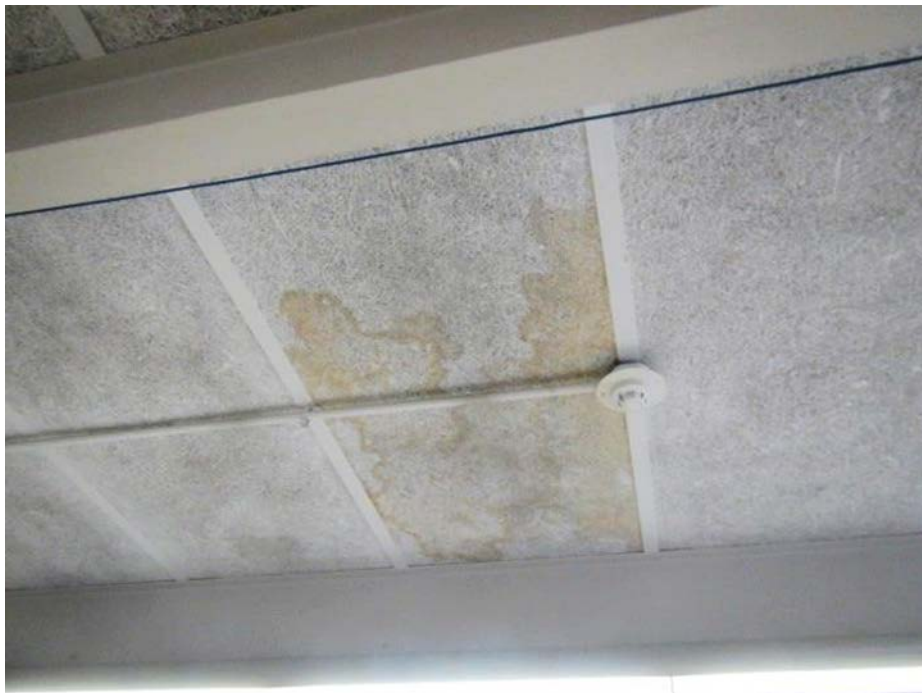
Picture 10

The roof was replaced over the last several years. No current leaks were reported, however a few water-stained ceiling panels were observed (Picture 10; Table 1), which are likely from historic damage. Note, these ceiling tiles are not porous but rather a tactile/rubberized material that would be resistant to mold growth.

Water-stained tactile ceiling panels

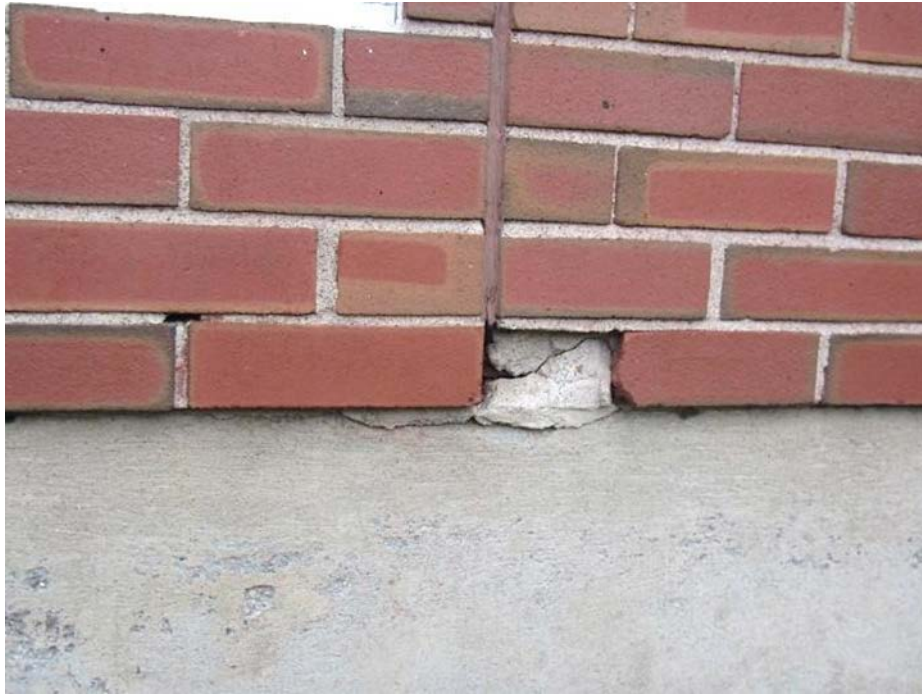
Picture 11

- missing/damaged mortar/brickwork (Picture 11);
- plants growing against the foundation/exterior (Picture 12); and
- a damaged garage door (Pictures 13 and 14), off the kitchen area.

All of these conditions can serve to hold moisture against the building or provide a source for moisture, drafts, odors, or pests to enter the building.

Damaged brick/mortar

7. Repair any missing/damaged exterior mortar/brickwork.
8. Repair or replace damaged garage door off the kitchen area.
9. Remove any vegetation within 5 feet of the foundation perimeter.

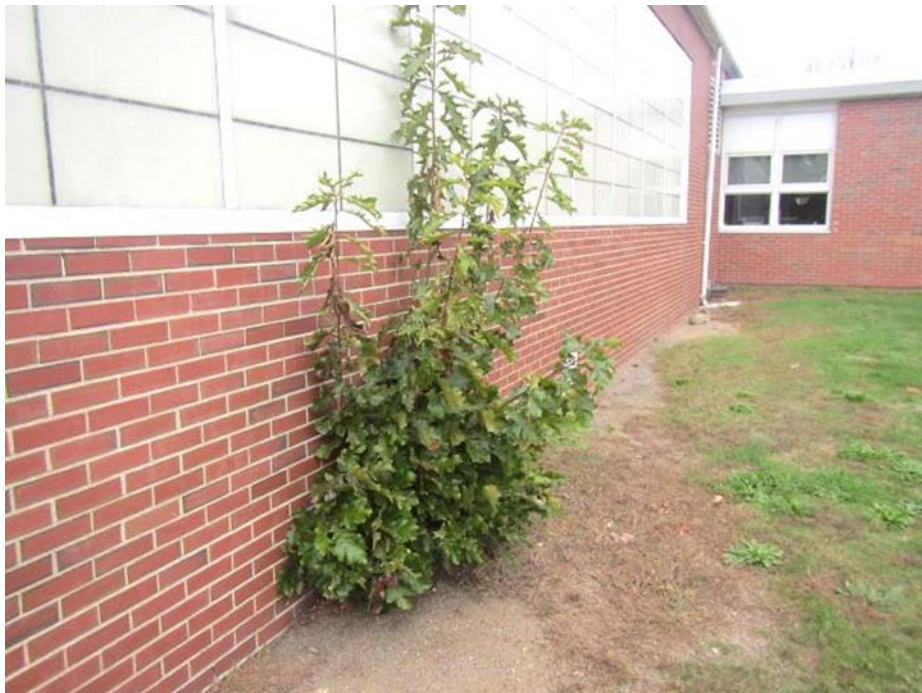
Picture 12

Plants growing against exterior wall

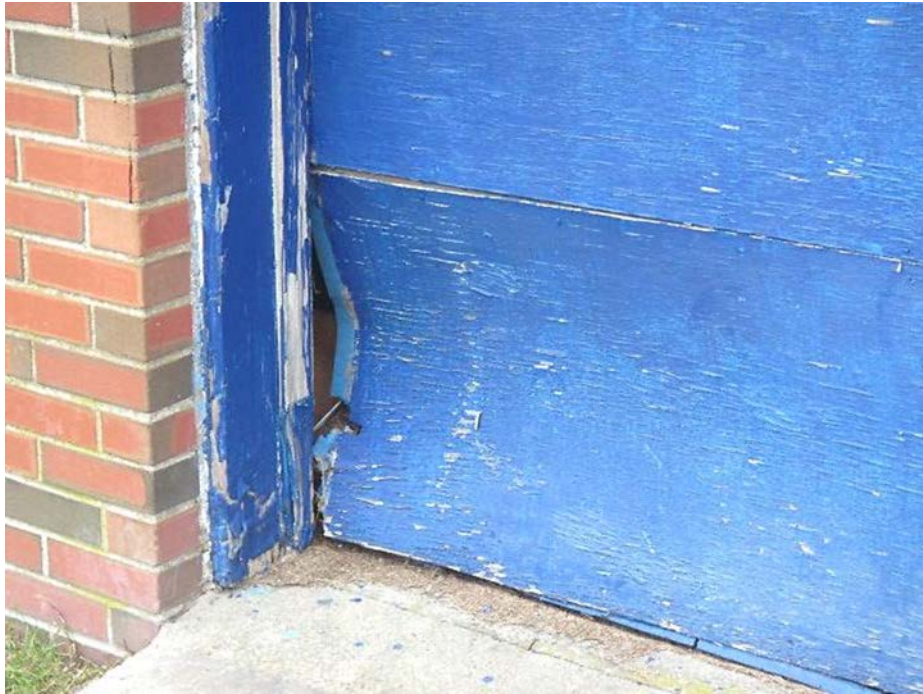
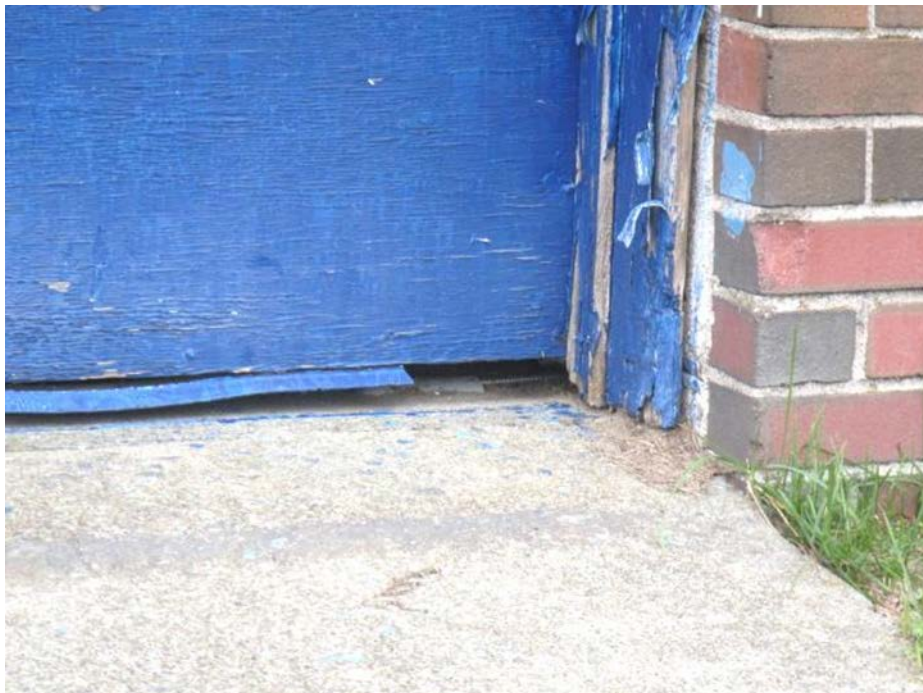
Picture 13

Damaged garage door near kitchen

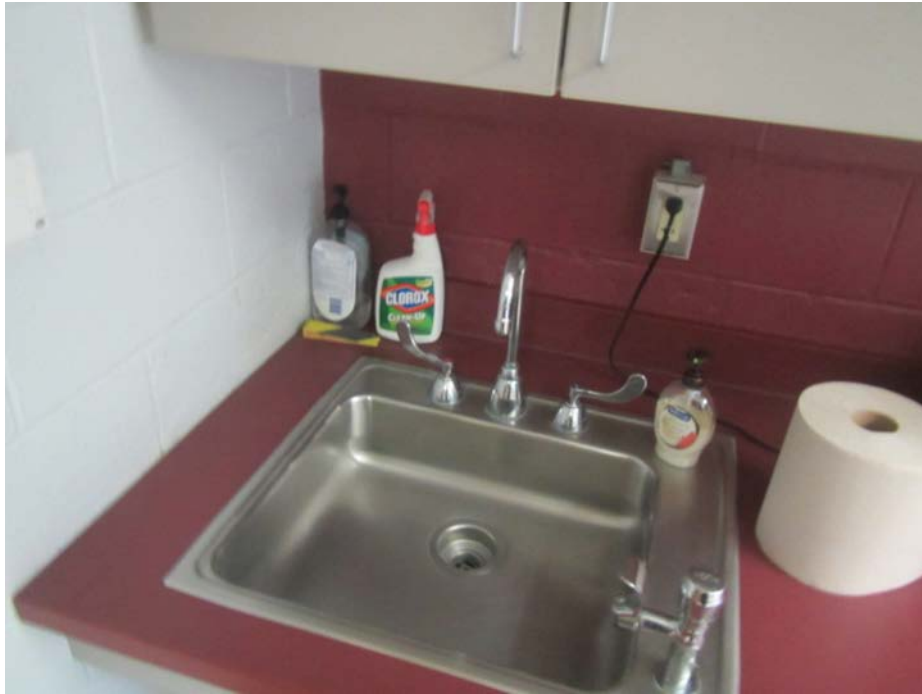
Picture 15

Exposure to low levels of total VOCs (TVOCs) may produce eye, nose, throat, and/or respiratory irritation in some sensitive individuals. To determine if VOCs were present, BEH/IAQ staff examined rooms for products containing VOCs. BEH/IAQ staff noted hand sanitizers, cleaners/spray bottles (Picture 15), plug-in air fresheners (Picture 16) and dry erase materials in use within the building (Table 1). All of these products have the potential to be irritants to the eyes, nose, throat, and respiratory system of sensitive individuals. In addition, spray bottles/cleaning products should be kept out of reach of children.

Spray cleaning product on sink countertop

13. Reduce use of products and equipment that create VOCs (e.g., air fresheners).
14. Keep spray bottles/cleaning products out of reach of children (e.g., in cabinets over sinks).

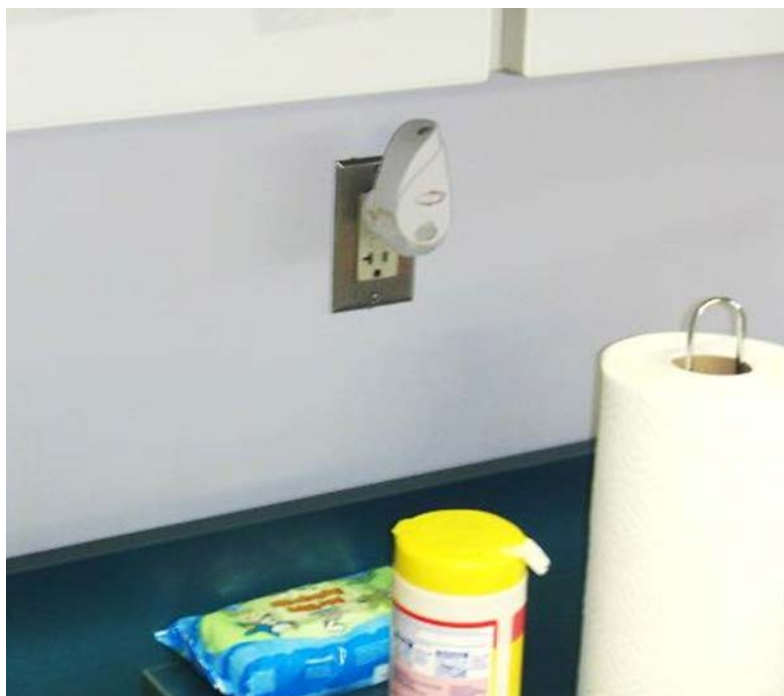
Picture 16

Plug-in air deodorizer

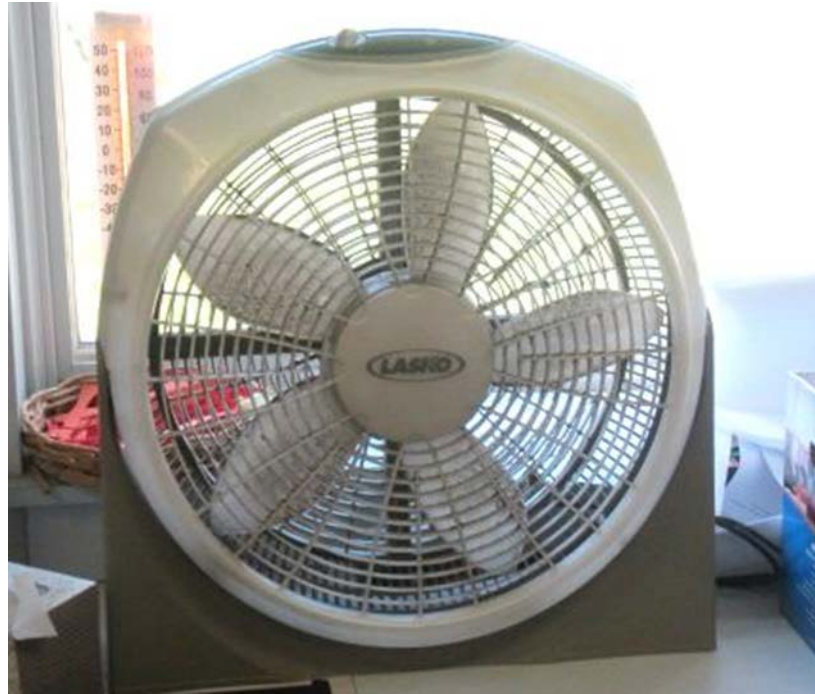
Picture 17

Most classrooms had personal fans or fans mounted on walls to provide circulation. Some of these had dusty blades/housing (Picture 17; Table 1). Some supply diffusers and exhaust/return vents (Picture 18) were also observed to be dusty. This dust can be reaerosolized when the equipment is activated.

Accumulated dust/debris on fan blades

16. Regularly clean/vacuum univent cabinets, supply/return/exhaust vents and fans to avoid aerosolizing accumulated particulate matter.
17. Clean window-mounted/portable AC filters prior to the start of the cooling season and according to the manufacturer's instructions.

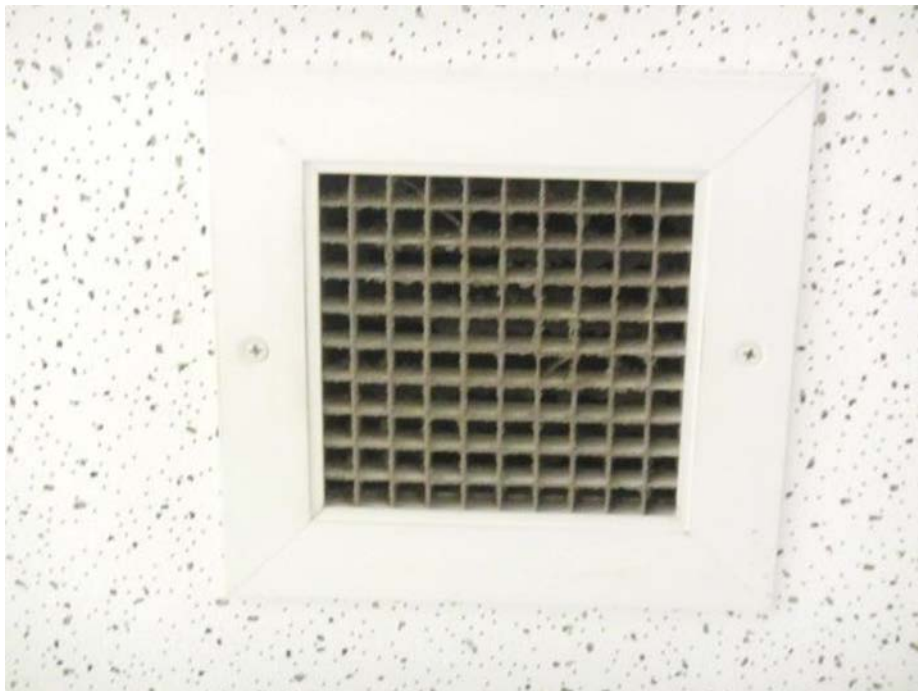
Picture 18

Accumulated dust/debris on exhaust vent
